JUSTIFICATION OF CAPITAL REPAIR OF A HIGHWAY BRIDGE WHEN CHANGING THE LOAD

Purpose. The purpose of the scientific article is to substantiate the implementation of capital repairs of a road bridge that has been significantly damaged as a result of hostilities. The achievement of this goal is based on numerical analysis of the model using the finite element method, taking into account recommendations for reinforcing bridge elements. Methodology. Loads and impacts gathered during numerical analysis ensure the verification of bridge structures and elements for strength, stability, and durability according to the first group of limit states criteria, as well as stiffness and crack resistance according to the second group of limit states criteria. Temporary loads and impacts for structures calculating for all groups of limit states are taken with reliability factors for loads γ_f and dynamics factors (1+\mu). The structure utilizes standard I-section beams for the superstructure with lengths of 22.16 m and 32.96 m, designed according to the working drawings and calculations developed by "International Design Institute" LLC and modeled in the professional structural analysis software Lir

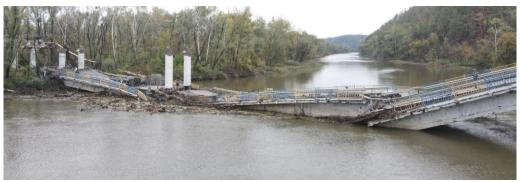
Fig. 1. Fragment of the general view of the destroyed bridge crossing

The bridge under study is located on a highway on the border of the settlement of Bogorodichne. The bridge was used for traffic in both directions and for pedestrians. The bridge was partially destroyed as a result of military aggression by the russian federation, and traffic across the bridge is currently impossible (Fig. 1).

The results of the survey indicate the following: 1) the bridge deck is effectively completely destroyed; 2) bridge spans No. 4-5, 5-6, 6-7, 7-8, 8-9, 9-10 are destroyed and require replacement; 3) complete destruction of supports No. 6, 7, 8 is noted; 4) the percentage of the approaches wear is 20 %.

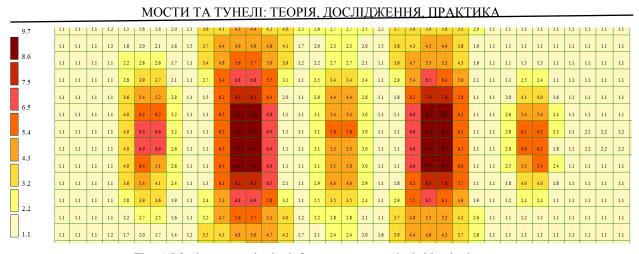
Fig. 6. Maximum required reinforcement across the bridge in the span

The structure of the temperature-continuous monolithic slab, calculated using the Lira-CAD structural analysis software, has been reinforced (Fig. 4) considering the entire range of loads. (Fig. 5-6).

We adopt the upper and lower main reinforcement of the slab in the spans:

- across the bridge as equal to Ø16 mm;
- along the bridge at least Ø12 mm.
