S. O. MELNYCHUK

RESULTS OF A COMPREHENSIVE ANALYSIS OF THE TECHNICAL CONDITION OF STEEL-CONCRETE COMPOSITE BRIDGES ON THE LVIV RAILWAY

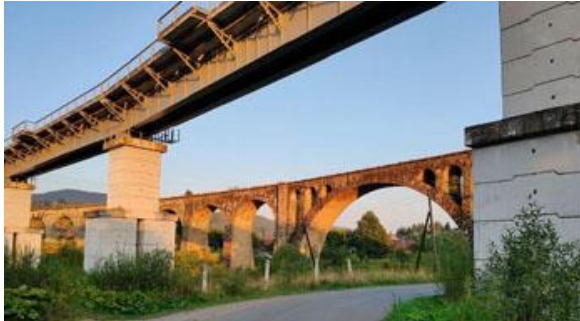
Figure 1. Constructed in the mid-twentieth century

“Lviv Railway” in particular, is characterized by a significant number of engineering structures whose service life is approaching or has already exceeded the design limit. A special place among them is occupied by steel-concrete composite bridges.

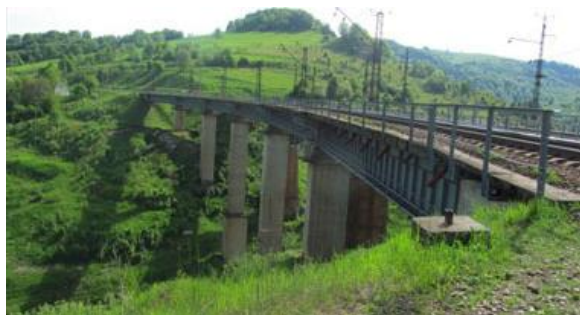
Figure 2. Steel-concrete composite viaduct in the mountainous terrain of the Carpathians

A structural feature of these bridges was the inclusion of a reinforced concrete ballast trough (with ribs up to 60 cm high) into composite action with metal riveted girders using shear connectors (Figure 3), which were welded after the girders were installed in the span.

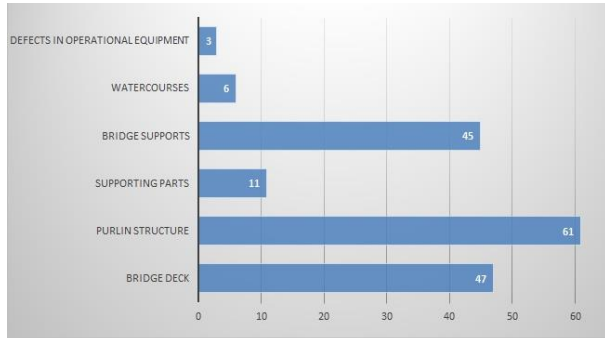
The number of identified defect types in the elements of the steel-concrete composite bridges (Figure 8) subjected to inspection within the scope of the study is presented above. The defect types are classified by codes in accordance with COY 45.120-00034045-015:2012 (2012). It was established that the largest number of defect types was found in the bridge superstructures.

Figure 8. Distribution of the number of defect types in the main elements of steel-concrete composite bridges of the regional branch “Lviv Railway”

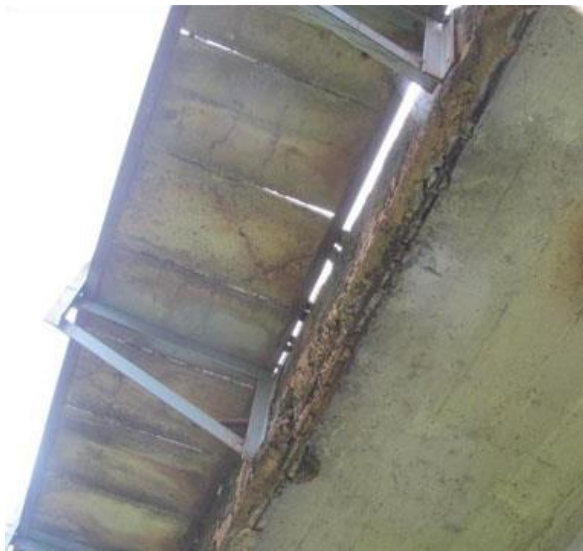
Figure 10. Defective reinforced concrete sidewalk blocks: leaching and deterioration of concrete, cracks, spalling

Code 2.1.213 (Defective reinforced concrete sidewalk blocks: leaching and deterioration of concrete, cracks, spalling) (Figure 10) was detected on 13 structures. This indicates the low quality or aging of the waterproofing in the sidewalk zone.

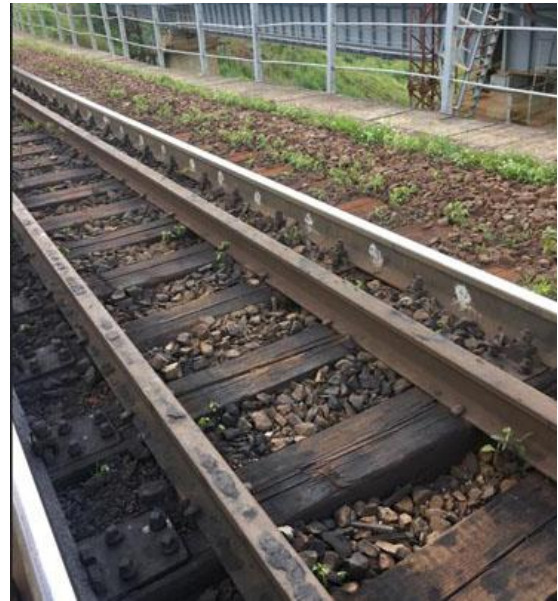
Code 2.2.72 (Defective sleepers, three or more in a row) (Figure 11) was recorded on 9 structures, which poses a threat to traffic safety due to possible track gauge widening.

Figure 11. Defective sleepers (three or more in a row)

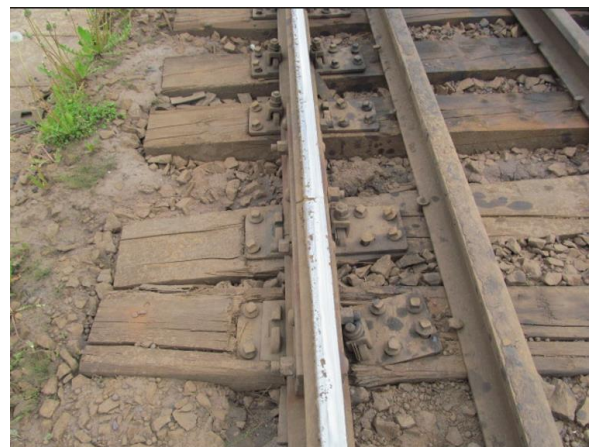
Code 2.2.20 (Defective rails on the bridge and its approaches) (Figure 12) was detected on 7 structures.

Figure 12. Defective rails on the bridge and its approaches

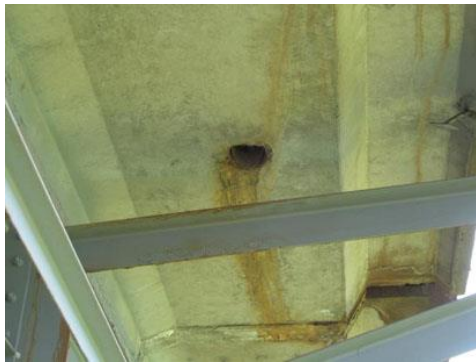
Code 3.1.26 (Defective or missing drainage pipes) (Figure 14) is the most widespread defect, recorded on 25 structures. Prolonged water soaking of the structures is the root cause for the development of subsequent damages.

Figure 14. Defective or missing drainage pipes

Since the root cause of the vast majority of damages is unsatisfactory drainage, the priority task is to localize the impact of moisture. In accordance with the requirements of ДБН В.2.3-22:2009 (2009) and ДБН В.2.3-6:2009 (2009), complete restoration or replacement of the destroyed waterproofing layer of the ballast trough (defect 2.1.213) using modern roll or mastic waterproofing materials is envisaged. Defective drainage pipes (defect 3.1.26) are subject to mandatory cleaning or replacement, and their length must be sufficient to drain water beyond the metal elements of the main girders.

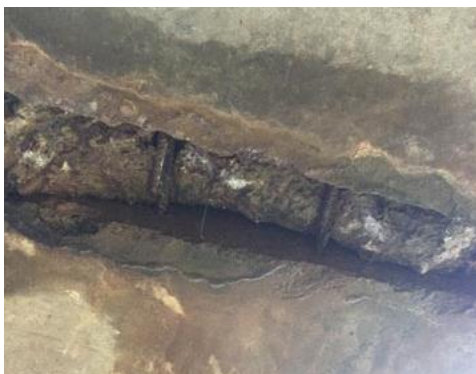
Codes 3.2.420 (Figure 15) and 3.2.430 (Figure 16) (Freeze-thaw damage to concrete and leaching of cement paste) were detected on 14 structures. Water that is not drained from the bridge deck penetrates the body of the reinforced concrete slab, washes out the cement gel, and, upon freezing, ruptures the concrete structure.

Figure 15. Freeze-thaw damage to concrete

Furthermore, to eliminate the consequences of freeze-thaw damage and concrete destruction (defects 3.2.420, 5.2.204), the restoration technology must comply with the requirements of the harmonized standard series ДСТУ EN 1504 (серія стандартів).

The technological process includes mechanical cleaning of damaged areas to sound concrete, anti-corrosion treatment of exposed reinforcement, and

restoration of the protective layer. The use of special non-shrink repair mortars on a polymer-cement basis (class R3 or R4) or the application of the shotcreting method is recommended to ensure high adhesion, frost resistance, and water resistance of the restored areas.

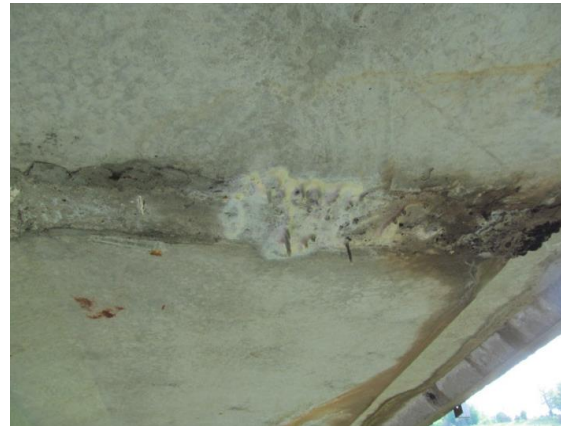
Figure 16. Leaching of cement paste

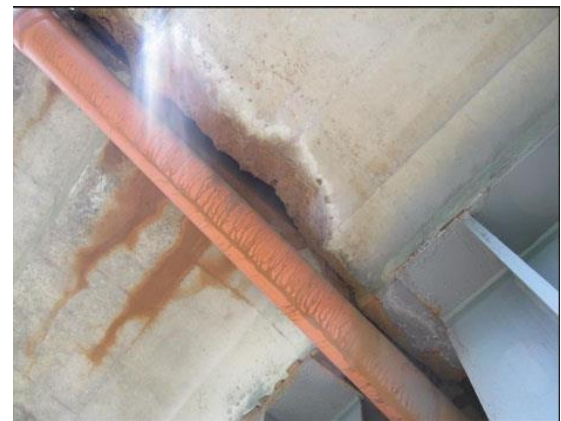
Code 3.3.392 (Lack of freedom of movement) (Figure 17) was recorded on 9 structures with spans exceeding 23 m.

Figure 17. Lack of freedom of movement

The abutting of superstructures against each other or against the abutment backwall causes additional unaccounted thermal stresses, which can lead to the shearing of anchors (flexible or rigid shear connectors) that integrate the steel and concrete.

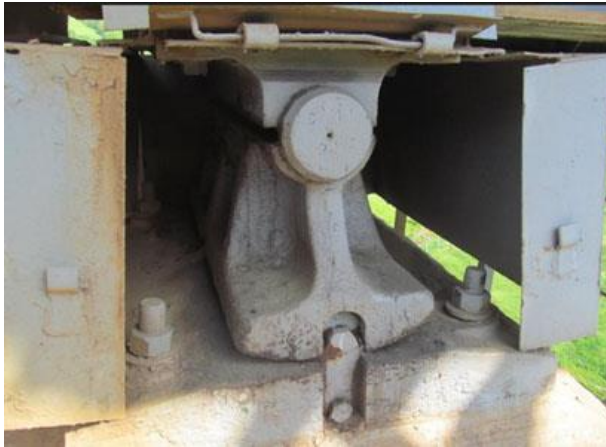
Code 4.2.11 (Undercutting of anti-creep teeth) was detected on 17 structures. This defect is a direct consequence of the jamming of the bridge bearings or the exceeding of the design longitudinal displacements of the superstructure (which correlates with defect 3.3.392).

Figure 19. Undercutting of anti-creep teeth

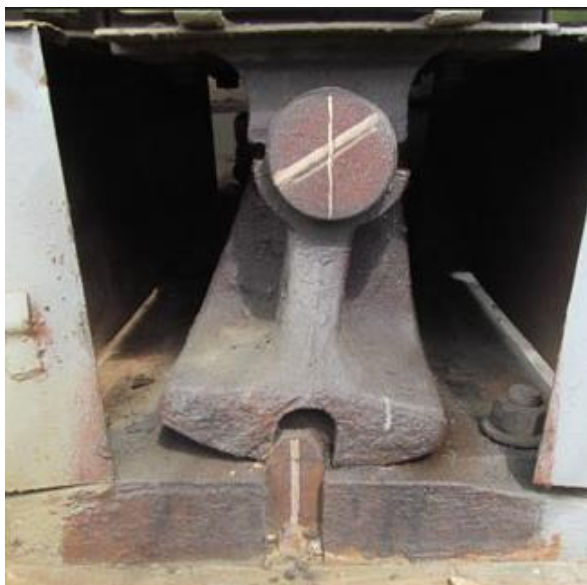
Code 4.1.10 (Deviation from the design relative position of the rocker and the base plate) – 12 structures.

Figure 20. Deviation from the design relative position of the rocker and the base plate

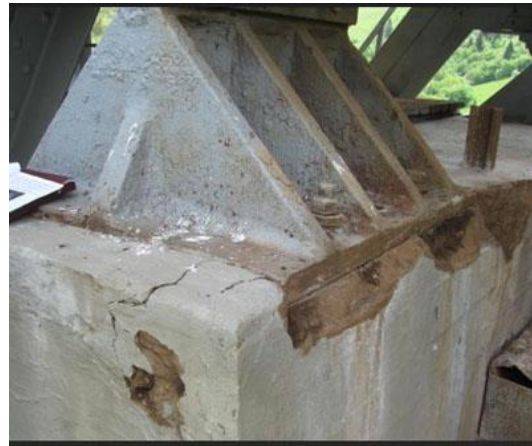
Code 4.1.2 (Loose bearing of the superstructure or bridge bearings) – recorded on 3 bridges, which causes dynamic impact effects during the passage of trains.

Figure 21. Loose bearing of the superstructure or bridge bearings

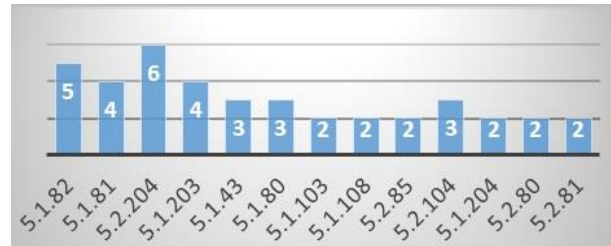
Figure 22. Distribution of the number of bridge pier defects by SOU 45.120-00034045-015:2012 codes

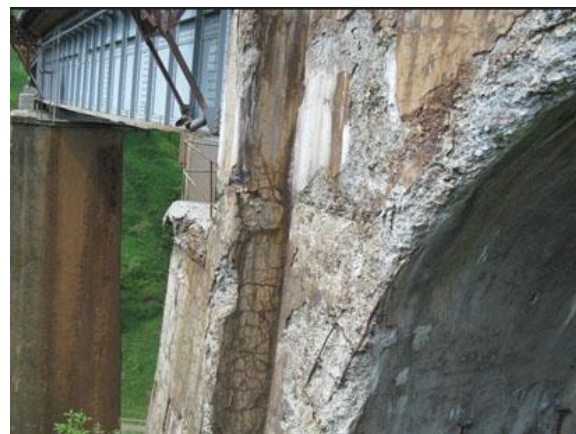
Code 5.2.204 and 5.1.82 (Freeze-thaw damage to the concrete of reinforced concrete and concrete abutment structures, respectively) were identified on 11 structures in total.

Figure 23. Freeze-thaw damage to the concrete of reinforced concrete abutments

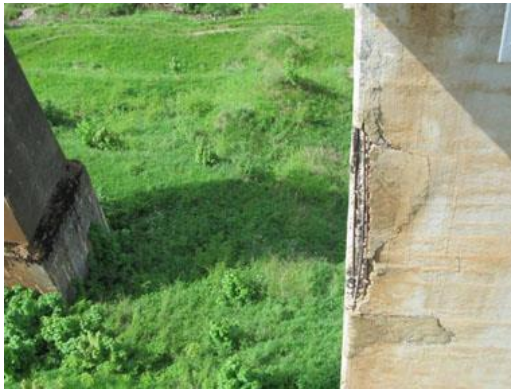
Figure 24. Freeze-thaw damage to concrete of reinforced concrete structures

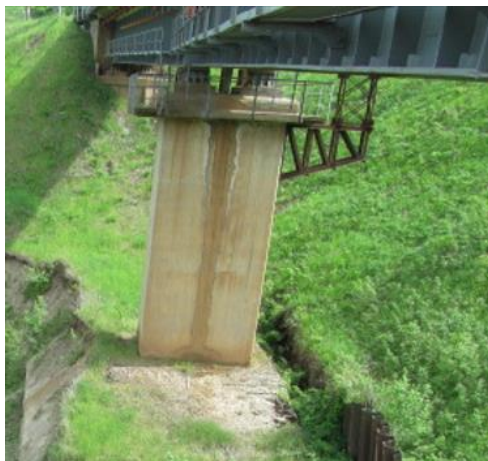
Code 5.1.203 (Leaching of cement paste) was recorded on 4 structures, which is often a consequence of water leaking from defective superstructure drainage systems onto the bearing pedestals and the pier body.

Figure 25. Leaching of cement paste
